**AN INVESTIGATION OF ROTATING STALL IN A
SINGLE STAGE AXIAL COMPRESSOR**

SUBMITTED IN PARTIAL FULFILLMENT
OF THE REQUIREMENTS FOR THE
DEGREE OF MASTER OF SCIENCE

MASSACHUSETTS INSTITUTE OF TECHNOLOGY
(1955)

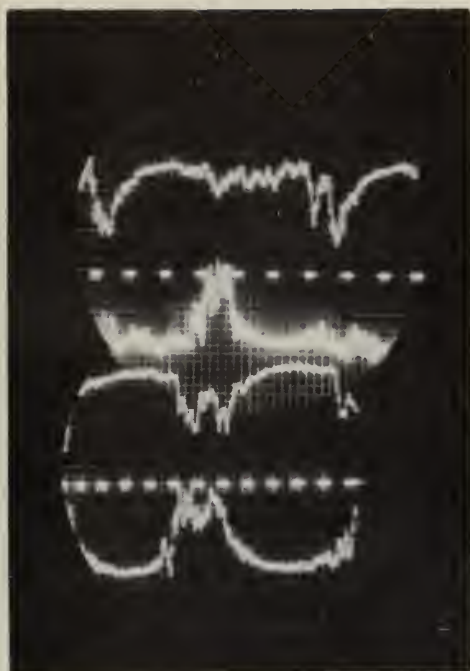
- a. $B_1 = 63.0^\circ$
 $F = 50 \text{ cps}$
 $N=1 \quad f = 7.85 \text{ cps}$

- b. $B_1 = 67.9^\circ$
 $F = 100 \text{ cps}$
 $N=2 \quad f = 15.5 \text{ cps}$

VELOCITIES DECREASE TOWARD
 THE CENTER OF EACH PICTURE
 PROBES DOWNSTREAM OF STATOR
 180° APART

- c. $B_1 = 73.8^\circ$
 $F = 100 \text{ cps}$
 $N=3 \quad f = 23.2 \text{ cps}$

The first sign of stall as β_1 was increased above the design value was the appearance of random velocity fluctuations, which appeared with increasing regularity until the regime of propagating tip stall was entered. The stalled region extended from the rotor tip for about $3/4$ inches down the blade, a distance approximately equal to the thickness of the boundary layer entering the rotor (Reference 7). The number of blades over which the region extended was greatest at the tip and decreased further down the blade, but no actual measurements were made of the number of blades covered by the cell. As β_1 was further increased, a single cell was found extending over the entire blade length, and the number of blades covered increased with β_1 until the next regime with two stall cells was entered. In the regimes where the entire blade was stalled, neither the velocity fluctuation pattern, nor the number of blades covered, varied markedly from root to tip. As β_1 was increased, the number of cells increased progressively from one to two to three, a larger number being unobtainable as purely random fluctuations appeared when β_1 was greater than 81° , as shown in Figure 4-d.

The single dot time trace as shown in Figures 4 and 6, was obtained by feeding the audio oscillator output into the z-axis. The z-axis terminals are located inside the cover doors on either side of the oscilloscope housing.

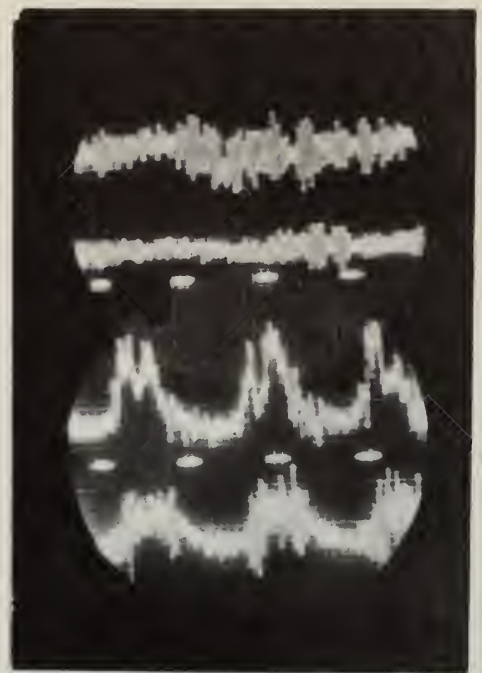
FIG. 6 STATIC PRESSURE FLUCTUATIONS WITH STATOR BLADES

a. 1 CELL

b. 2 CELLS

THE HOT WIRE TRACE IS ADDED FOR COMPARISON

Pressure fluctuations were measured with a barium titanate crystal, the output of which was fed through an amplifier, and thence to the oscilloscope. The pressure taps were located in the outer casing of the compressor before and after each blade row and representative photographs of the pressure fluctuations at various axial positions are shown in Figures 6 and 7.

With stator blades in position, it was found that pressure fluctuations were negligible downstream of the stator blades and upstream of the inlet guide vanes, as compared with the fluctuations upstream of the rotor. The fluctuations downstream of the rotor were not greatly affected by the onset of rotating stall but in the extreme condition an appreciable variation is seen (Figure 6c). The upstream fluctuations due to rotating stall were approximately double those downstream of the rotor. It would appear from this that the condition of a constant downstream pressure field, as assumed by Stenning, was not satisfied and therefore the close agreement between theoretical and observed propagation velocities must be considered fortuitous.
